SUBJECT: BOYLSTON BUILDING REDEVELOPMENT - PARCEL 31  
THEATER DISTRICT

PROPOSED DETERMINATION  
OF DECADENT OR BLIGHTED OPEN CONDITIONS  
BOYLSTON BUILDING  
BOSTON, MASSACHUSETTS

Staff Report  
Massachusetts Government Land Bank  
19 January 1981

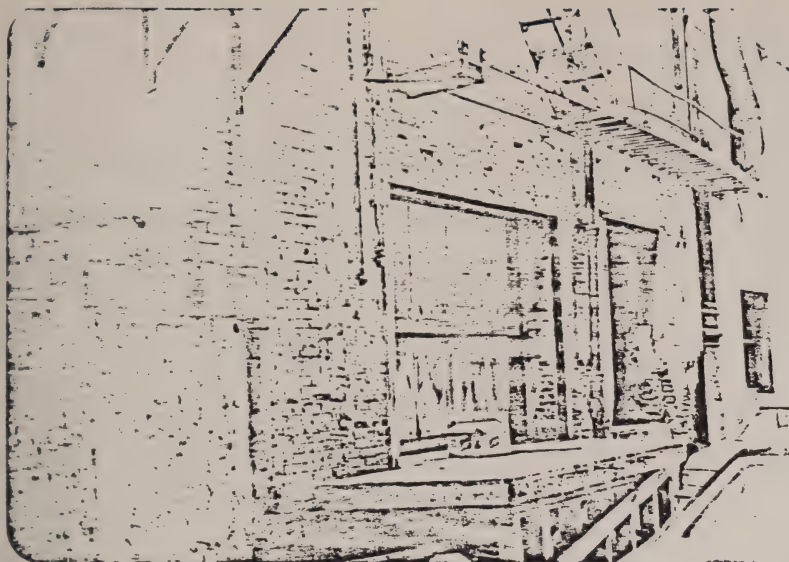
7. Existing docking facilities with small wooden platform.
